Manhole Inspection Summary

Manhole # S27G__015MH

Insp Date: **5/23/08 8:24 AM**

Location Address: **1000 N Schroeder St**

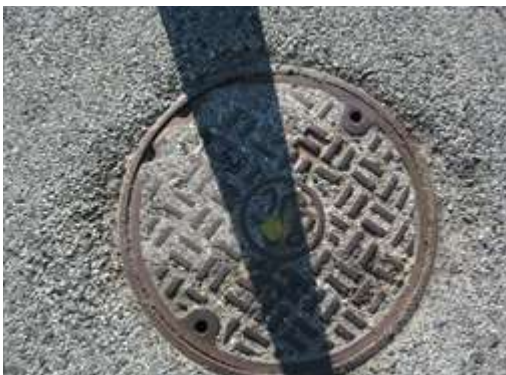
Cover View

Condition: **Sound**

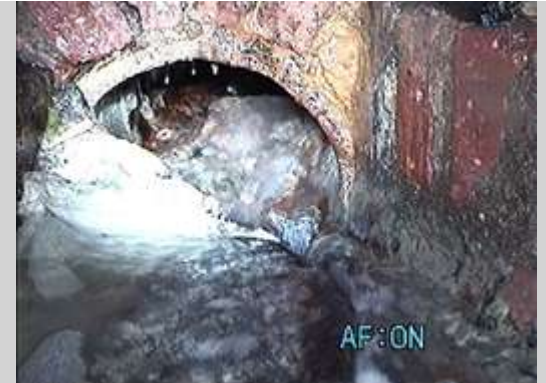
12 O'Clock Outflow

8 in. Circular Gravity Sewer
Pipe Out @ 12 O'Clock

Pipe Height: **7.2** (in.) Rod and Bar (Angled)
Pipe Material: **Clay** ☐ Pipe Lined
Invert Depth: **10.05** (ft.) Flow Characteristics: **Slow**
Deposits: ☒ None ☐ Mud ☐ Sludge ☐ **Debris** ☐ Grease
Silt Depth: **0** (in.) Deposits Extent:
Infiltration: **None** Pipe Seal Cond: **Sound**

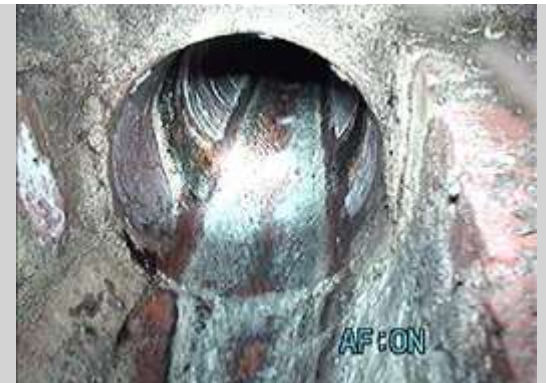
3 O'Clock Inflow

6 in. Circular Gravity Sewer
Pipe In @ 3 O'Clock

Pipe Height: **6** (in.) Rod and Bar (Angled)
Pipe Material: **Clay** ☐ Pipe Lined
Invert Depth: **9.58** (ft.) Flow Characteristics: **Slow**
Deposits: ☒ None ☐ Mud ☐ Sludge ☐ **Debris** ☐ Grease
Silt Depth: **0** (in.) Deposits Extent:
Infiltration: **None** Pipe Seal Cond: **Sound**
